## Assessment of conventional French railway sub-structure: a case study

# Assessment of conventional French railway sub-structure: a case study

Duong T.V.<sup>1</sup>, Cui Y.J.<sup>1</sup>, Tang A.M.<sup>1</sup>, Calon N.<sup>2</sup>, Robinet A.<sup>2</sup>

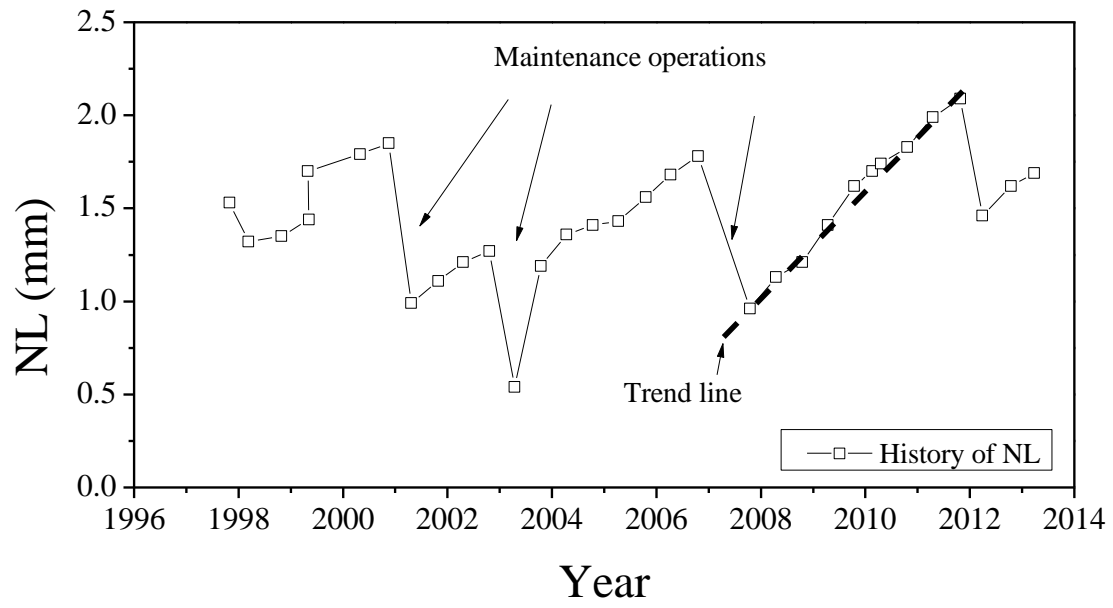
199 Fig. 9 presents the variations of  $NL$  at kilometer 70.3 of Track 2 from 1997 to 2013. It can be observed  
 200 that the value of  $NL$  decreased sharply after each maintenance (in the year of 2001, 2003, 2007 and  
 201 2012). However, after the maintenance, the value of  $NL$  continued to increase at almost the same rate: a  
 202 linear increase trend of  $NL$  over time can be identified. It is worth noting that the slope represents the  
 203 increase rate of  $NL$  or the degradation rate of tracks. The increase trend of  $NL$  persisted after a  
 204 maintenance, suggesting that ballast replacement did not resolve the problem, and the track degradation  
 205 was rather related to the sub-structure.

455 **Fig. 9: History of NL variations for a given kilometer, with maintenance operation**

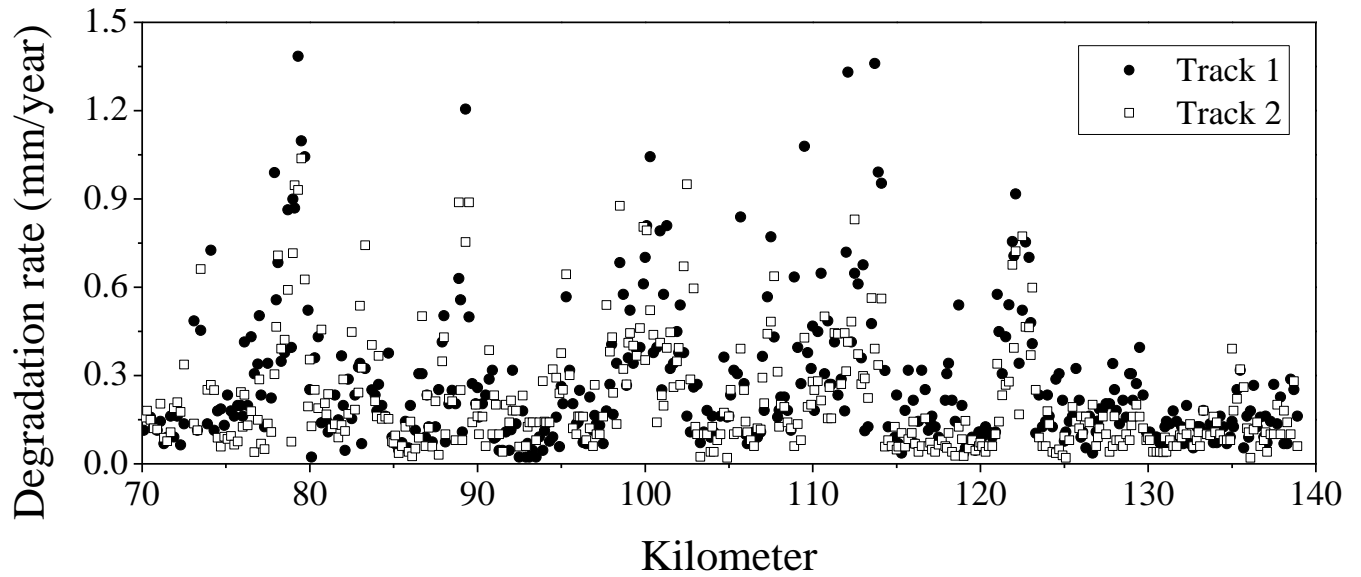
235 Fig. 12 depicts the degradation rate (the increase of  $NL$  per year which was calculated from the  
236 slope as presented in Fig. 9) versus the kilometer point for Track 1 and Track 2. On the whole, there is  
237 an agreement between the data of two tracks; the peaks of Track 1 appeared almost at the same  
238 kilometer points as the peaks of Track 2.

252 From Fig. 12, the zones with high degradation rates can be identified. They are around PK 73,  
253 79, 88, from 99 to 103, from 106 to 114 and 122. Referring to the geological information, it can be  
254 concluded that these kilometer points correspond to the zones where sub-grades contains large fraction  
255 of fine particles. Around PK 73, the sub-grade is rather argillaceous limestone and marl. Around PK 79,  
256 the sub-grade is fine alluvial deposits and peat. From PK 88 to 89, it is the alluvial deposits overlying the

257 argillaceous limestone or marl or peat. From PK 98-103, the sub-grade involves argillaceous limestone,  
258 marl and fine limestone. Around PK 113, the sub-grade contains sometimes colluviums. It is important  
259 to note that these soils are sensitive to changes in water content and train loading. Soils like peat, alluvial  
260 deposit and colluviums are very compressible and do not have the required mechanical properties for  
261 sustaining the train-induced load. This can explain the high increase rate of *NL* in these zones. From PK  
262 123 to the end of the line, the increase rate of *NL* became low along the line, indicating a good  
263 performance of the tracks. This can be also explained by the sub-grade nature: hard limestone is  
264 involved along this section. For the first part of the line (up to PK 103), the sub-grade soils are quite  
265 variable. These changes in soil natures are also detrimental to the track performance.

464  
465 **Fig. 12: Degradation rate along the studied line**

266 From the analysis above, it can be seen that the sub-grade has a significant influence on the  
267 performance of railway structure. From a practical point of view, the zones with a sub-grade of low  
268 mechanical properties are not apt to become the foundation of railway sub-structure. If it is inevitable,  
269 improvement must be conducted in order to meet the requirements, such as a good drainage system or  
270 some soil improvements.

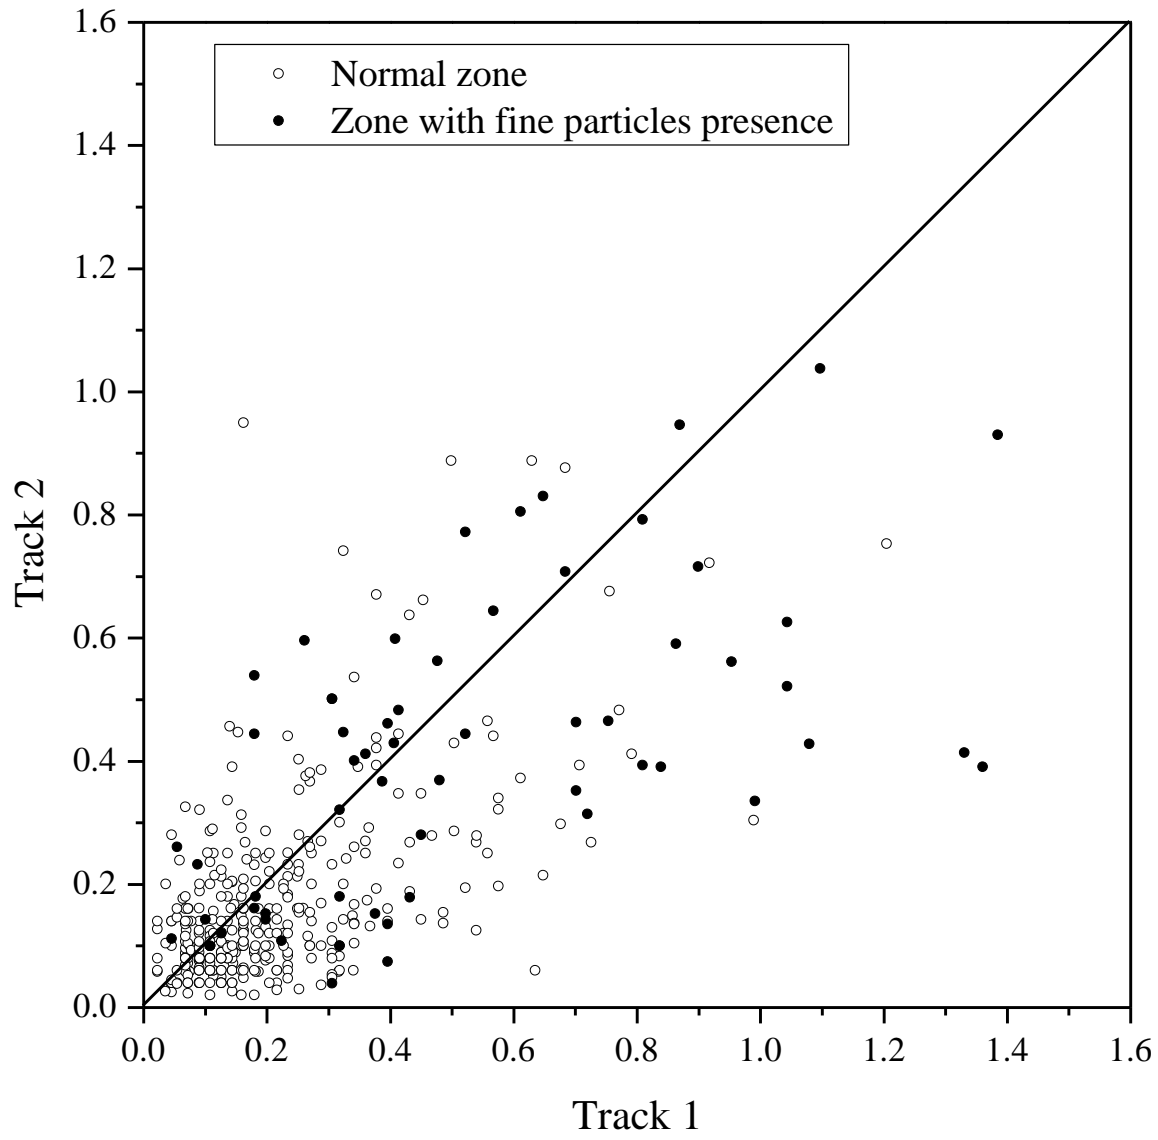
271 Fig. 15 presents the correlation between the degradation rates of Track 1 and Track 2. It is  
272 observed that the *NL* of Track 1 increased more quickly than that of Track 2, because more data fall  
273 below the equality line. This is in agreement with the finding in the first part of work where the number  
274 of sub-structure related problems were recorded (Fig. 4). It is normally admitted that the train heading to  
275 the center (up line) carrying more freights and passengers than the train leaving the center (down line).  
276 More studies are needed to clarify this observation.

277 During the assessment of the whole line, the zones where fine particles were found on the ballast  
278 layer surface were identified. The degradation rates of these zones are presented in Fig. 15 with the black  
279 symbols. It can be seen that most of the zones with the presence of fine particles correspond to the zones

280 with high increase rate of  $NL$ . These fine particles came probably from the sub-grade when mud  
281 pumping occurred. This implies that the sub-grade containing large fraction of fine particles is  
282 detrimental to the performance of sub-structure. Indeed, for this kind of sub-grade soils, a decrease of  
283 mechanical performance can be expected when the moisture content rises. It appears thereby important  
284 to further investigate the effect of water content of sub-soil having large fine particles fraction and also  
285 the mud-pumping phenomenon.

476 **Fig. 15: Correlation between degradation rate of Track 1 and Track 2**

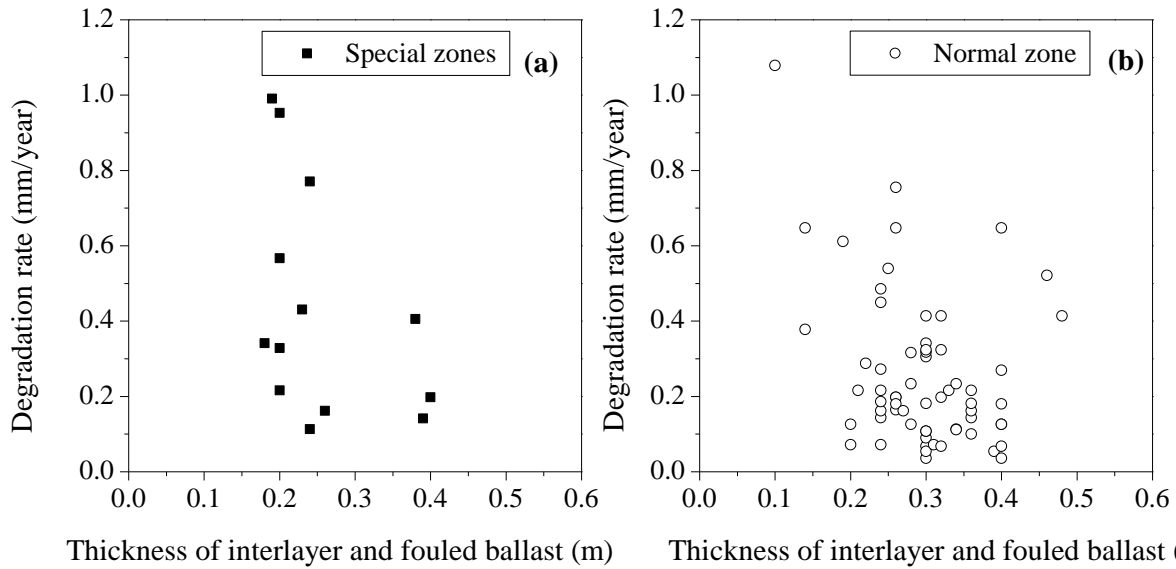
286 Fig. 16 presents the correlation between the thickness of fouled ballast and interlayer ( $e$ ) and the  
287 increase rate of  $NL$  for special zones (Fig. a) and normal zones (Fig. b), for Track 1. The same  
288 correlation is presented in Fig. 17 for Track 2. The special zones correspond to the zone of stations, the  
289 zones with bridges or viaducts. The other zones are referred to normal zones. For the special zones,  
290 Track 1 (Fig. 16a) presents a sharp decrease trend of degradation rate with the increase of  $e$ , while this  
291 trend is not observed for Track 2 (Fig. 17a). For the normal zones, despite the data scatter that can be  
292 explained by the presence of fouled ballast taken into account in the study, both Track 1 (Fig. 16a) and  
293 Track 2 (Fig. 17a) present a decrease of degradation rate as the layers thickness increases. As mentioned  
294 before, in the sub-structure of new lines for high speed train, there are a number of layers protecting

295 more or less the sub-grade. On the contrary, in the sub-structure of conventional lines with the absence  
296 of an appropriate transition layer such as the sub-ballast layer, significant stress can be exerted to sub-  
297 grade soils, leading to significant deformation of tracks or degradation of tracks. The presence of  
298 interlayer somehow plays the role of a transition layer to reduce the stress applied to sub-grade. This  
299 explains the decrease trend of the degradation rate with the increase of  $e$ .

479 Thickness of interlayer and fouled ballast (m) Thickness of interlayer and fouled ballast (m)  
 480 **Fig. 16: Correlation of the degradation rate to the thickness of interlayer and fouled ballast for Track 1- Data from**  
 481 **coring train. a) special zones and b) normal zone**

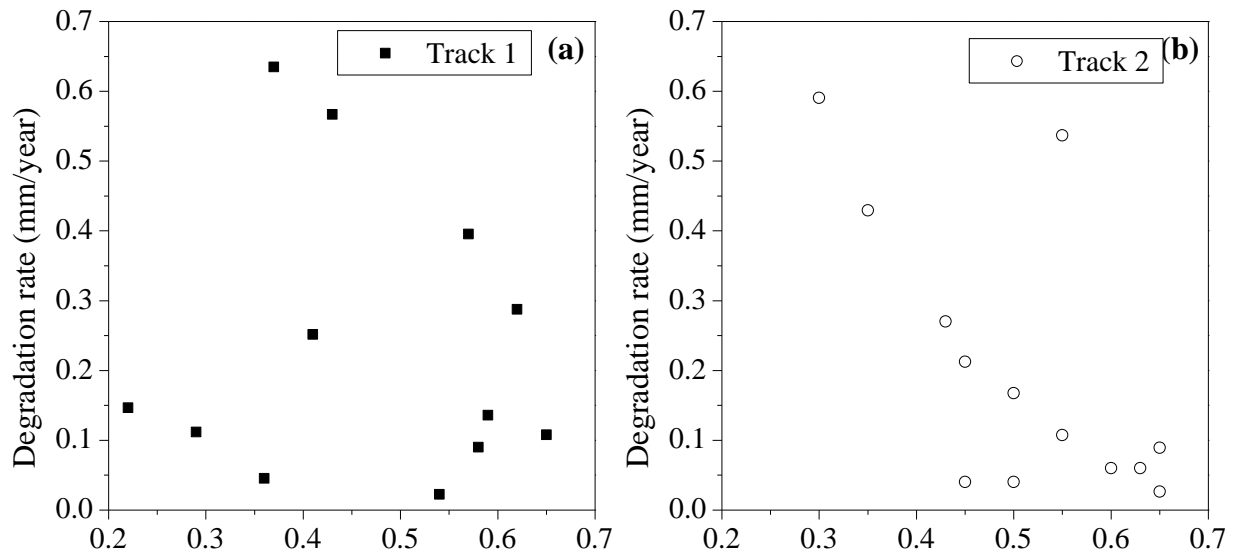
300 This trend is also observed in Fig. 18 where the layer thickness deduced from Panda  
301 penetrometer tests and endoscope observation is used. The trend is not clear for Track 1 but very clear  
302 for Track 2. This confirms the positive impact of interlayer in reducing the degradation of tracks with the  
303 increase of interlayer thickness. Note that in other countries, the presence of some layers such as capping

489 Thickness of interlayer and fouled ballast (m) Thickness of interlayer and fouled ballast (m)  
 490 **Fig. 18: Correlation of the degradation rate to the thickness of interlayer and fouled ballast - Data from Panda and**  
 491 **Endoscope. a) Track 1 and b) Track 2**
