Impact of excavation damage on the thermo-hydro-mechanical properties of natural Boom Clay

Linh-Quyen Dao, Yu-Jun Cui, Anh Minh A.M. Tang, Jean-Michel Pereira,
Xiang-Ling Li, Xavier Sillen

Linh-Quyen Dao, Yu-Jun Cui, Anh Minh A.M. Tang, Jean-Michel Pereira, Xiang-Ling Li, et al.. Impact of excavation damage on the thermo-hydro-mechanical properties of natural Boom Clay. Engineering Geology, 2015, 195, pp.196-205. <10.1016/j.enggeo.2015.06.011>. <hal-01271302>

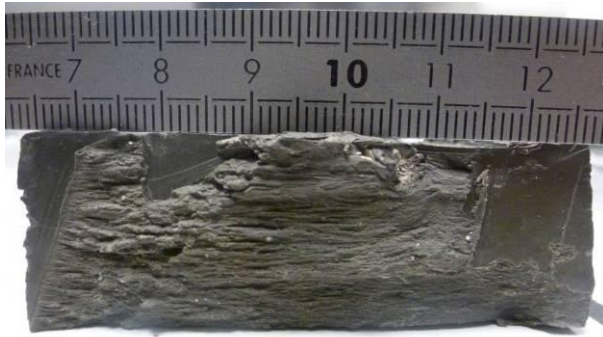
Figure 5: Bedding plane on natural Boom Clay sample.
