Mechanical impact of wires break in grouted external prestressing tendon

Jonas Aparicio, Tien Hoang, Gwendal Cumunel, Gilles Forêt, Yannick Jeanjean, Julien Castres Saint Martin

¹ Navier, Ecole des Ponts, Univ Gustave Eiffel, CNRS, Marne-la-Vallée, France

² Sanef, Issy les Moulineaux, France

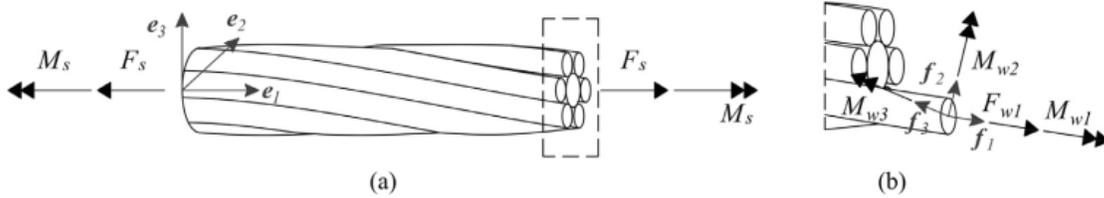
Fig. 2. (a) Straight strand subjected to axial-torsional loads. (b) Generalized stresses on the wire cross section.

FIGURE 1. Force and moment generalised on the strand and on a helical wire extracted from Foti & Martinelli (2019)

between wire are expressed in the helical Fresnet coordinate system (Figure 1). The articles reviewed differ about how they solve contact, model traction or take into account Poisson Effect and wire flattening but they all rely on symmetry which makes them no longer valid for damaged strand which has seen less theoretical and experimental works.

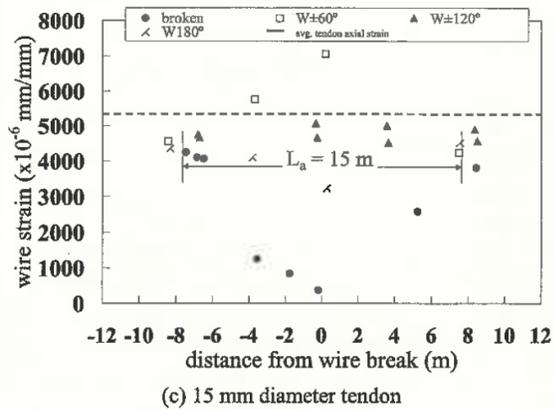
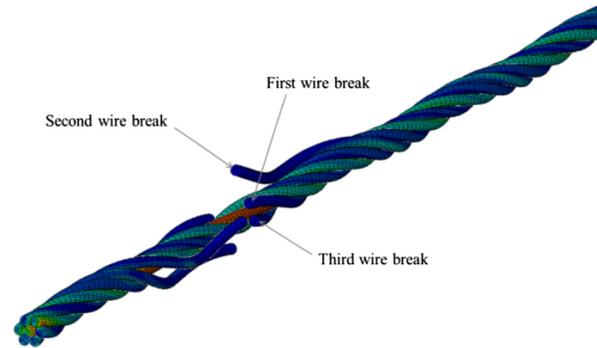
Fig. 10—Outer wire strains for tendons with single broken wire.

Fig. 21. Multiple wire breaks.

FIGURE 2a. Strain distribution in a strand with a broken wire extracted from MacDougall & Bartlett (2003) **FIGURE 2b. Numerical model of a strand with wires breaks extracted from Abdullah et al. (2016)**

There are fewer studies about the breaking of individual wire. MacDougall & Bartlett (2003) investigated the re-anchoring of one or two wire in a strand. Cutting of individual wire in a strand with a concrete deviation lead to transfer length of more than 10 meters. The transfer is partial as tension in the strand go down by 2-4% each cut, in a 7 wire strand each wire account for around 14% of the tension. This paper shows that stress redistribution in the wires is symmetric but not homogeneous. Tension after the cut in each wires depends on its relative position to the cut wire (Figure 2a). Beltrán et al. (2018) use analytical and FE computation to derive the static response of a strand with a broken wire, the strand is unbounded. Both of this article assume that damage of broken wire induce a helical displacement of the strand to respect equilibrium. A tentative confinement has been done on the The numerical and experimental study conducted by Abdullah et al. (2016) (Figure 2b) with unstressed strands surrounding the stressed strand in which wires are cut. Prestress loss is only 10% less with the confinement than without. Stress transfer is worse than in MacDougall deviated strand. Transfer length has been measured as the 30 meters between the cut and the end of the bench.

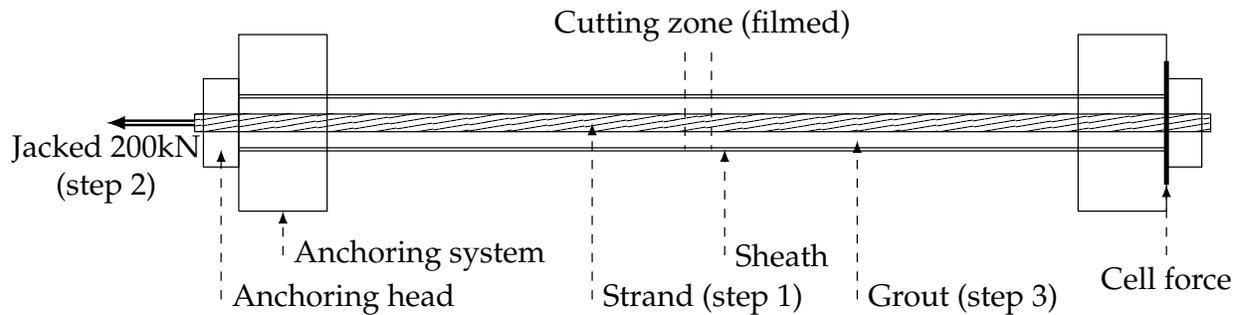
FIGURE 3. Sketch of the experimental set-up for a tendon with one strand

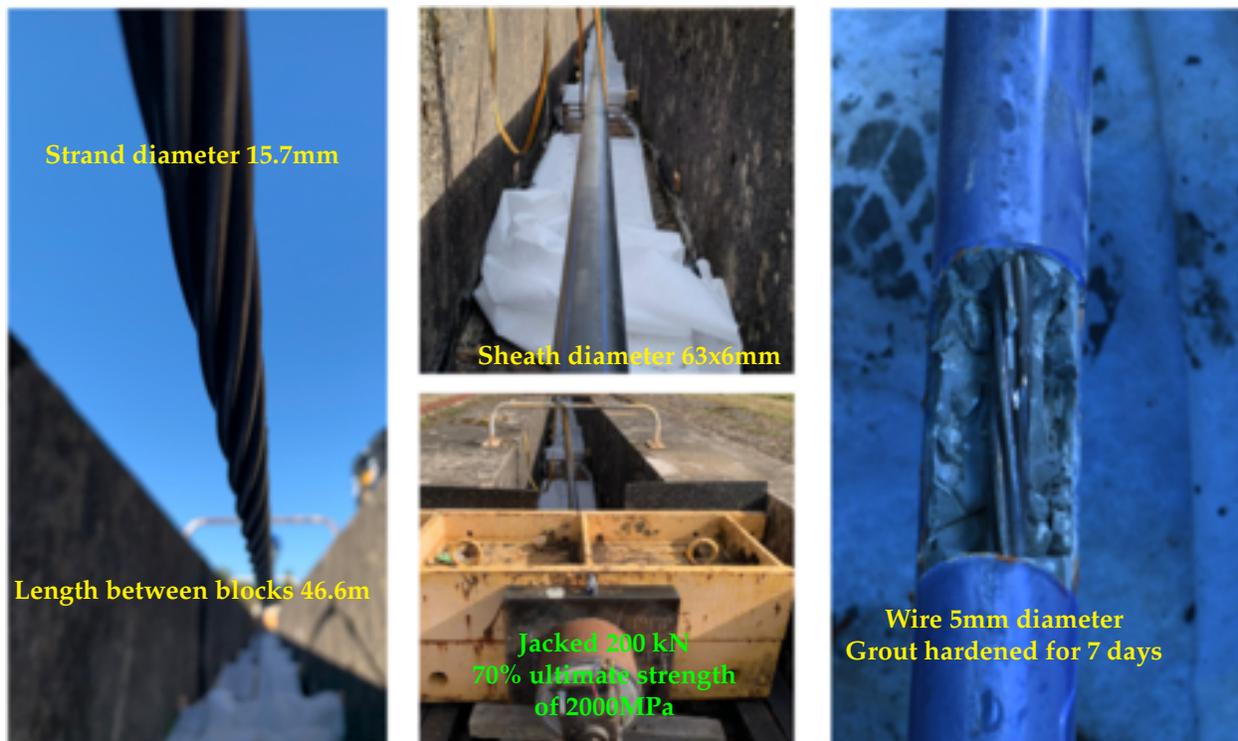
FIGURE 4. Photos of the experimental bench at various step of the experiment set up

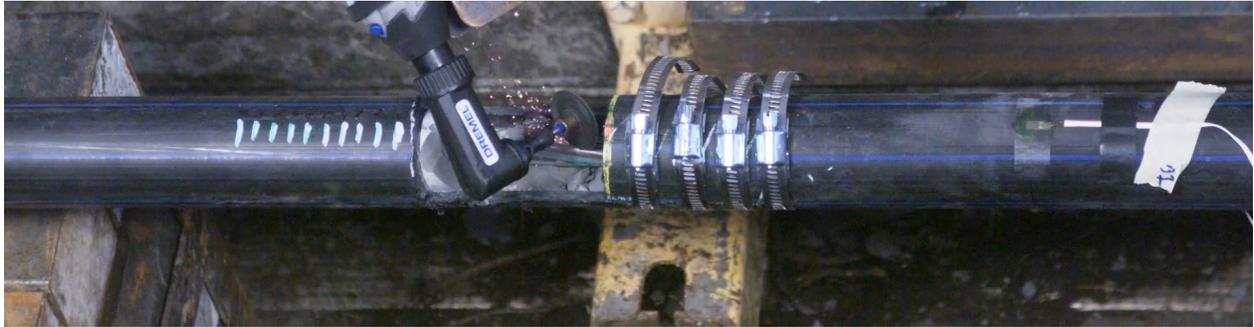
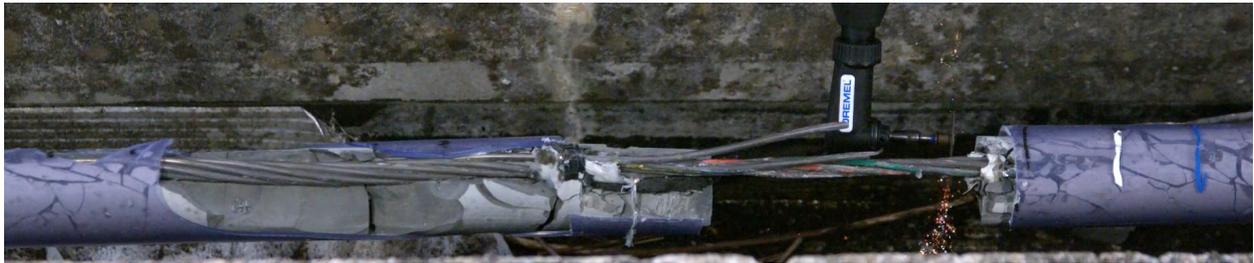
FIGURE 5.a Second cut of the third mono strand

FIGURE 5.b Third cut of the thirist mono strand

FIGURE 5. Photos of cutting

welded together. In the first two experiments, the center part of the sheath was made of transparent PVC to allow visually following of the crack propagation in the grout, with the PVC and HDPE sheath connected by a screw joint. A grouting vent was provided for better grouting quality. Anchoring systems were installed at both ends with a force cell at the passive end. Tension was applied with a hydraulic jack at the active end at 70% of the tendon’s braking strength (step 2 on Figure 3) . The tendon was then injected with Holcim Superstresscem grout, which is widely used for this type of application (step 3 on Figure 3). The 5 tendons had a length of 46.6 m between the two anchor blocks. After allowing the grout to sit for 7 days, a 20-cm trapdoor was made in the sheath to access the wire and the grout was removed in the trapdoor so that the wires could be cut one by one with a Dremel mini rotary saw during testing (Figure 5).

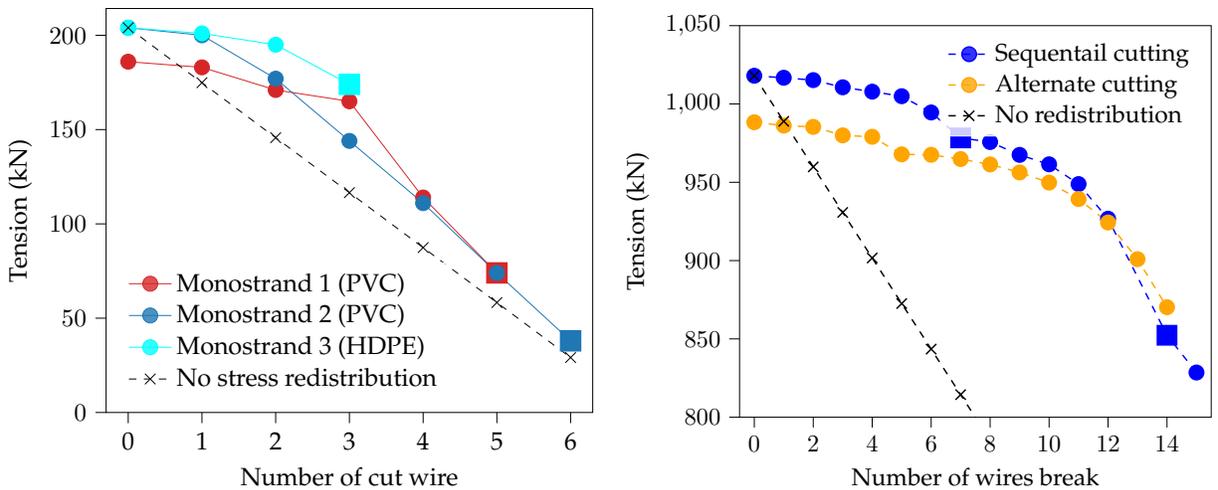
FIGURE 6a. Tension in the monostrand according to the number of wire cut

FIGURE 6b. Tension in the 5T15 according to the number of wires broken

When a wire is cut, some of the tension it was carrying is lost and some is transferred to other wires in the tendon. Furthermore, the transfer in the sheath and grout is not taken into account because they were removed to perform the cutting of the threads. However, this is unlikely to introduce a significant bias because the tensile strength of the grout and the stiffness of the sheath are very low compared to those of the steel. The stress transfer efficiency then appears to be directly correlated to the bond between the wires and the grout. When the confinement of the steel decreases due to excessive damage to the grout, the stress transfer decreases to almost zero (Figure 6a). Sheath failure, which occurs with the brittle PVC sheath in the first two experiments, causes the grout to rupture and the strand and grout to split over a distance of several meters (Figure 4b). In general, grout degradation due to multiple ruptures tends to make stress transfer less and less efficient as damage increases in the tendon (Figure 6a and 6b).

Monostrand The experiment display two different behaviours for monostrands depending of the sheath used. On the one hand, when a PVC sheath is used for the first two strands, the wire breaks cause the sheath to rupture followed by large cracks in the grout. There is then a loss of bond between the grout and the tendon over a length that increases with each cut. When the tendon is debonded from the grout, which occurs at the 4th cut for monostrand 1 and at the 2nd cut for monostrand 2, each cut causes the tension in the tendon to drop by a value only slightly less than the initial tension of the cut wire, showing that the tension transfer during wire cutting is minimal, with most of the tension lost (Figure 6a).

There is uncertainty about the exact value of stress transfered and tension loss at each wire cut that will translate into an uncertainty about the number of wire loss that will cause the tendon to break. This is because this transfer depends on stong dynamic effect, the cracking of the grout, the exact position of the wire and the relative position of every other wires, in a real tendon the dispersion of tension between the tendon. This will lead to a small discrepency of result even trough the experiments done show the first two monostrand and the two tendon with 5T15 having close behaviour, eventhrough the 5T15 was submitted to two very different cutting schedule (Figures 6a and 6b).

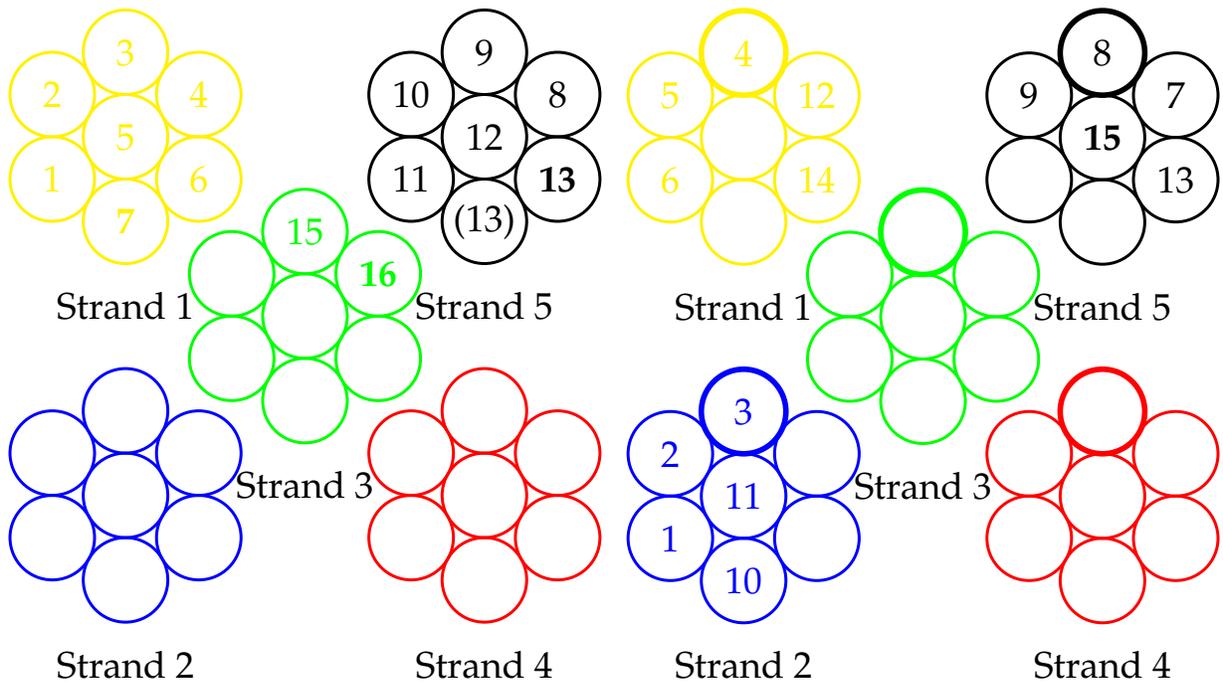
FIGURE 7a. Sequential cutting schedule

FIGURE 7b. Alternate cutting schedule

In the first one, wires were cut in the same strand until the strand break before cutting wires in another strand. This was called the sequential cutting (Figure 7a). The second strand broke on the sixth cut on this strand (in total the thirteenth), with the entire tendon breaking on the second cut in the third strand. In the second, one wire was cut on 3 different strands. The original plan was to cut 3 wires on each strand, then 2 and finally 1. But accessibility constraints made it impossible to access some wires and an adjustment had to be made as a last resort (Figure 7b). There is little tension loss at each cut until the very end albeit tension loss of individual cut tends to get bigger as the damage of the tendon increase and when a strand finally breaks. There is strong evidence suggesting that stress of the cut wire is not only redistributed in the strand which it belongs but also in the others strands. Sequential cutting see failure of strand after 6 and 7 cuts. Failure would have occurred earlier if stress was only redistributed in the strand being cut. But the redistribution of the tension is not homogeneous in the strands. The high-frequency film of the rupture of the tendon subjected to alternative cutting shows that the outer 4 strands fail before the central one, even

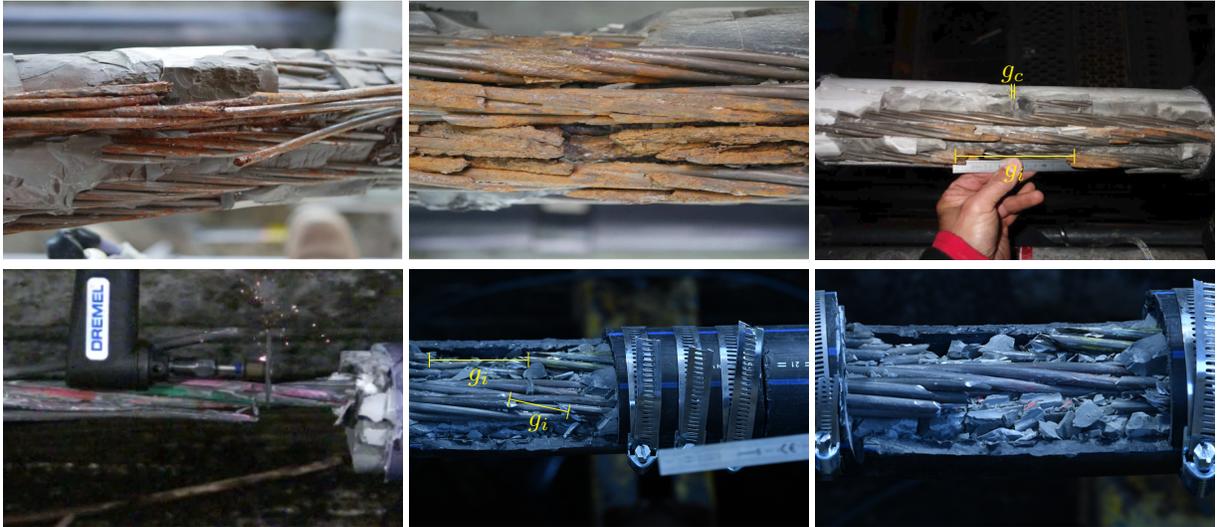
FIGURE 9. Up photos of damage on opened tendon on a bridge © IFFSTAR for Sanef. Down photos of broken wire during the experiments

Figure 9 shows different degree of damage on site and during the experiment. Sliding depends on the state of the tendon, with sliding bigger when whole strand are cut. It can be hard to distinguish displacement due to sliding and loss of mater due to dissolution cause by corrosion.

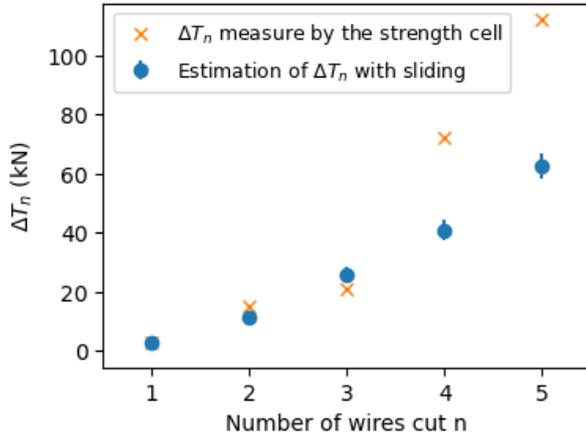
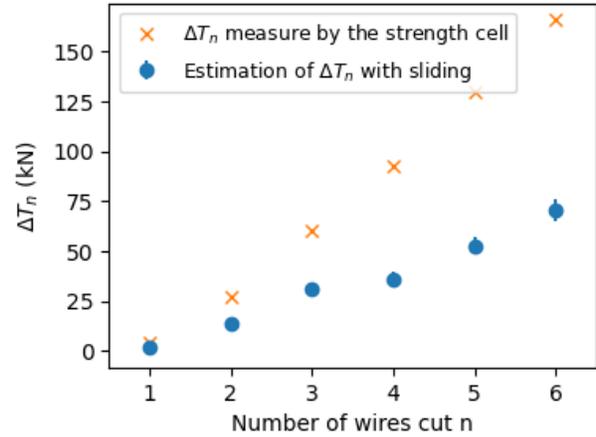
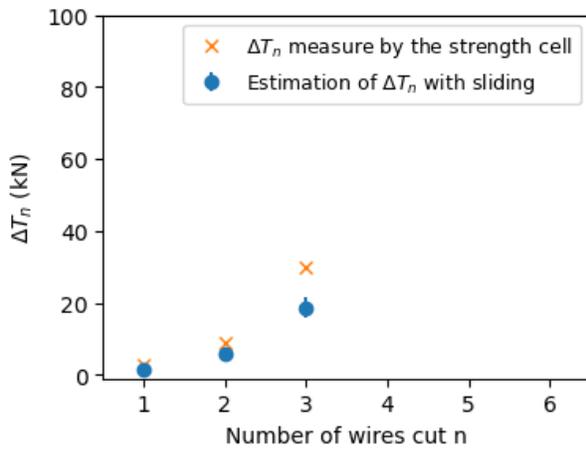
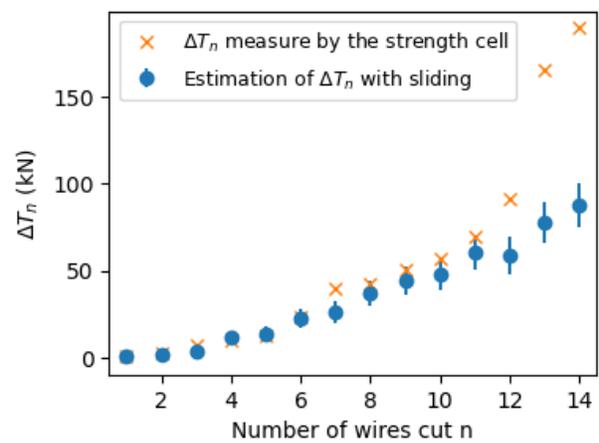
FIGURE 11.a Monostrand 1

FIGURE 11.a Monostrand 2

FIGURE 11.a Monostrand 3

FIGURE 11.a Sequential

FIGURE 11. Comparison tension loss measured by the sensor and estimated with sliding

At each cut, a new wire slide and sliding of the already cut wires increase. This phenomenon account for the quasi-quadratic evolution of the total tension loss (ΔT_n) for the first few cut (Figure 11). There is no estimation for the 5T15 with alternate cutting schedule as the angle of the camera during this experiment makes it very hard to get an estimation of the sliding with the chosen precision. Figure 11 shows the comparison between measured tension loss ΔT_n and estimated tension loss due to sliding according to the number of cut n . The sliding of the grout was not used for the estimation as the grout broke and fell into the bench during the experiment. It leads to an underestimation of the tension loss, which makes it conservative. The error bar is done assuming sliding is known ± 1 cm. This uncertainty is due to the measurement of sliding done using photo of the tendon and having to account to angle of view effect and inaccuracy due to end of some wires being out of the field of view, hidden by the strand or the sheath. The sliding has to be extrapolated using the wires where the two end are visible. Only sliding of the wire is considered as sliding of the grout can't be measured on the two monostrand due to grout breaking and falling into the bench. The loss of tension due to rotation is not considered in the model. As rotation is not permitted during tension,

an important torque is created in the strand (see Ghoreishi et al. (2007) for models linking elongation to torque). As damage of the strand cause relaxation of the torque, a twist is created on both side of the strand. This twist will cause the tension in the strand to further decrease. The transfer of tension to the grout and the loss of tension due to the freeing of strand rotation are supposed to be responsible for the difference between the model and loss of tension measured by the strength cell.
