## Assessment of conventional French railway sub-structure: a case study

Trong Vinh Duong, Yu-Jun Cui, Anh Minh A.M. Tang, Nicolas Calon, Alain  
Robinet

Trong Vinh Duong, Yu-Jun Cui, Anh Minh A.M. Tang, Nicolas Calon, Alain Robinet. Assessment of conventional French railway sub-structure: a case study. *Bulletin of Engineering Geology and the Environment*, 2015, 74 (1), pp.259-270. 10.1007/s10064-014-0575-y . hal-01271093

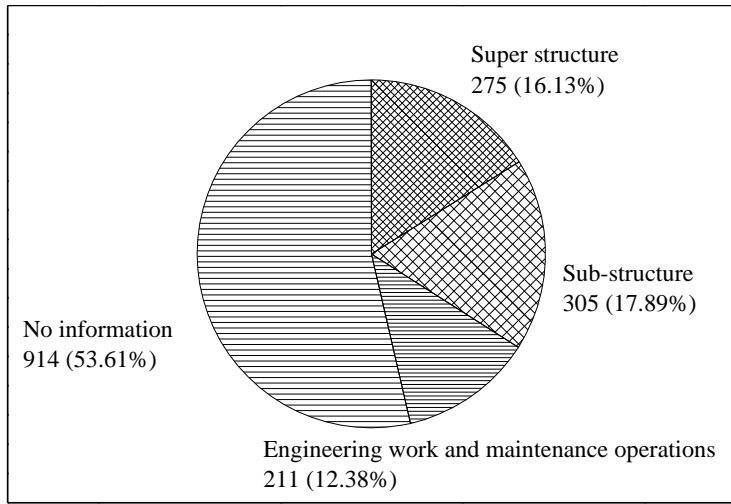
433 **Fig. 1: Cause of the problems for the deceleration of train**

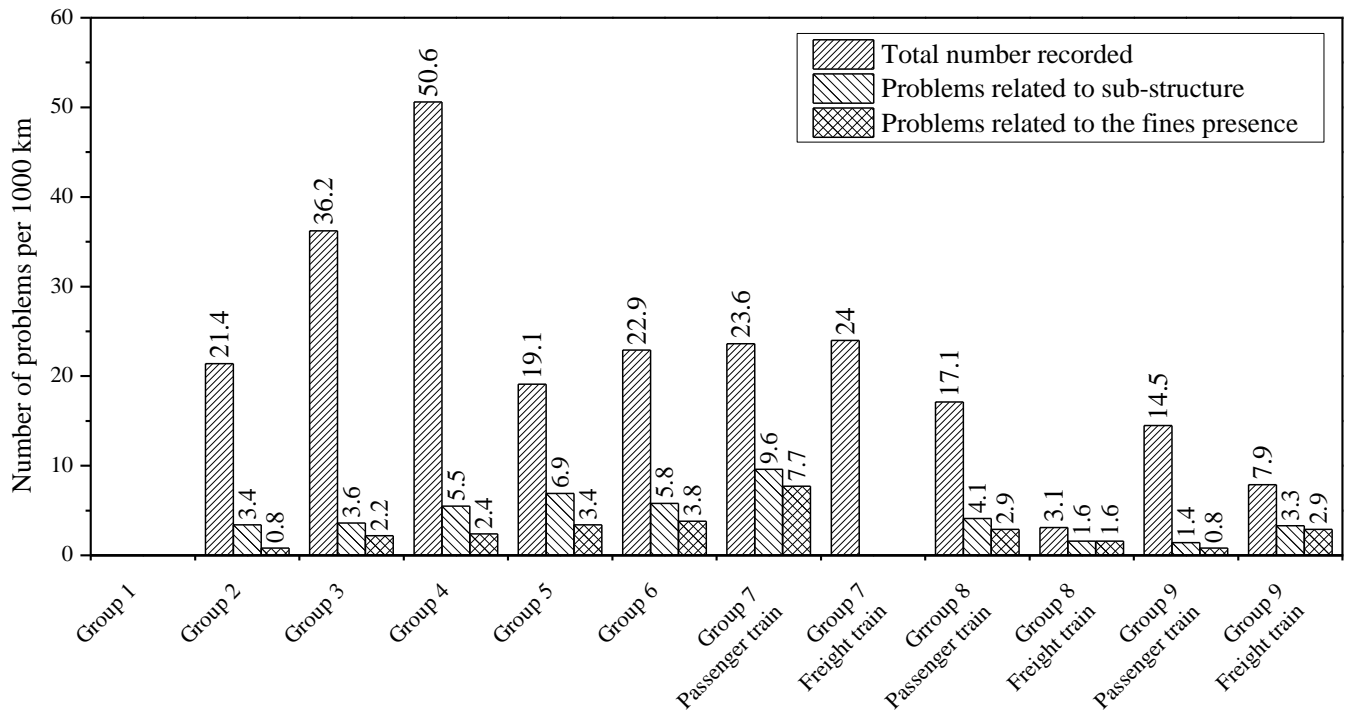
435 **Fig. 2: Number of problems versus group UIC**

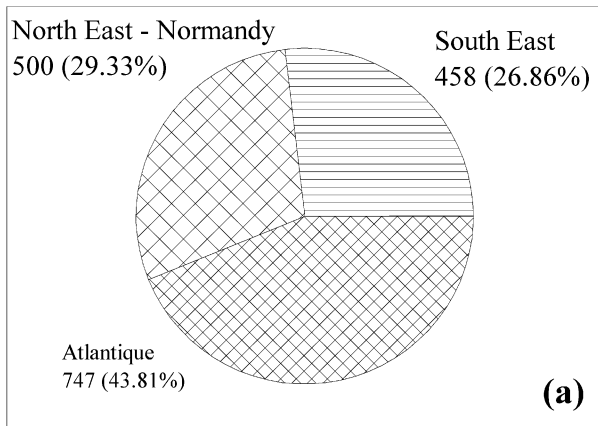
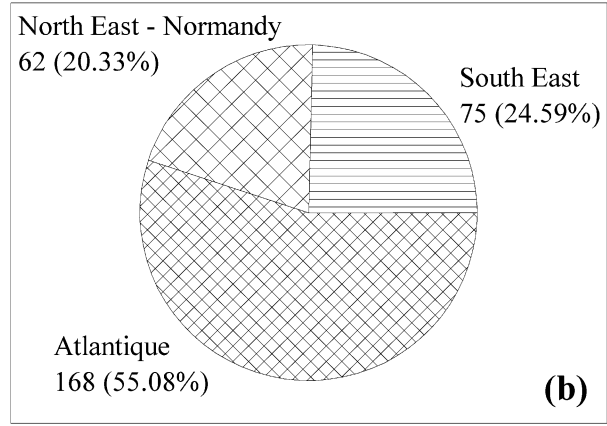
443 **Fig. 5: Classification of problems according to the territory. a) All problems; b) Problems related to sub-structure and**  
 444 **c) sensitive zones**

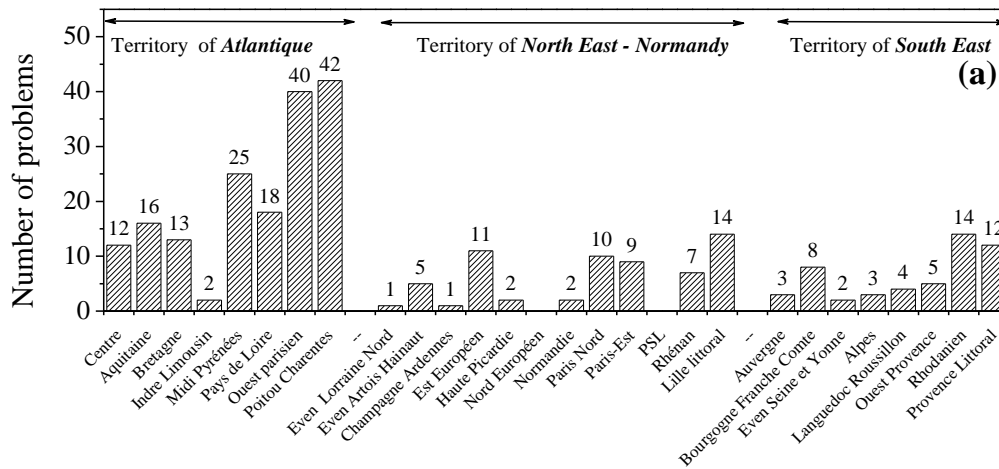
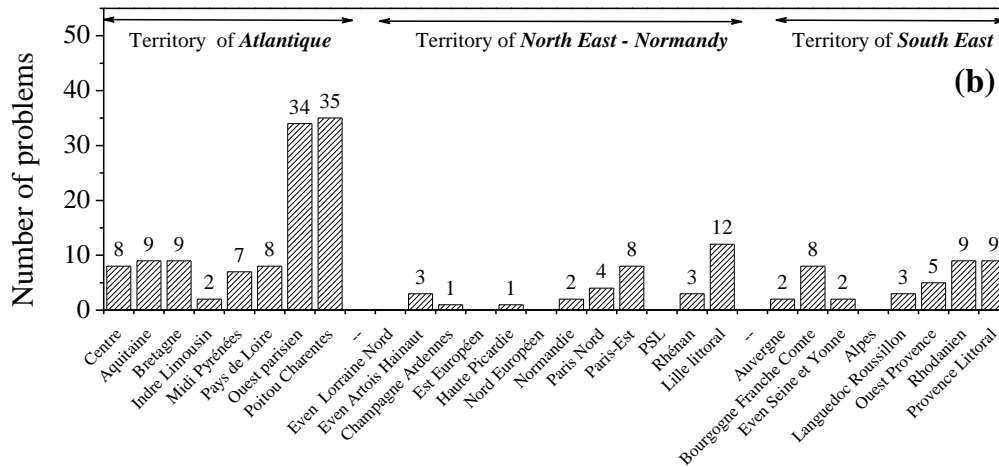
447 **Fig. 6: Classification of problems according to the Infrapole. a) Problems related to sub-structure and b) problems**  
 448 **related to sensitive zone**

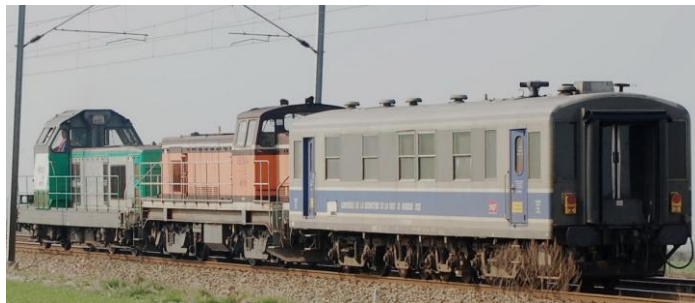
Fig 8a: Mauzin train  
(<http://lapassiondutrain.blogspot.f>)

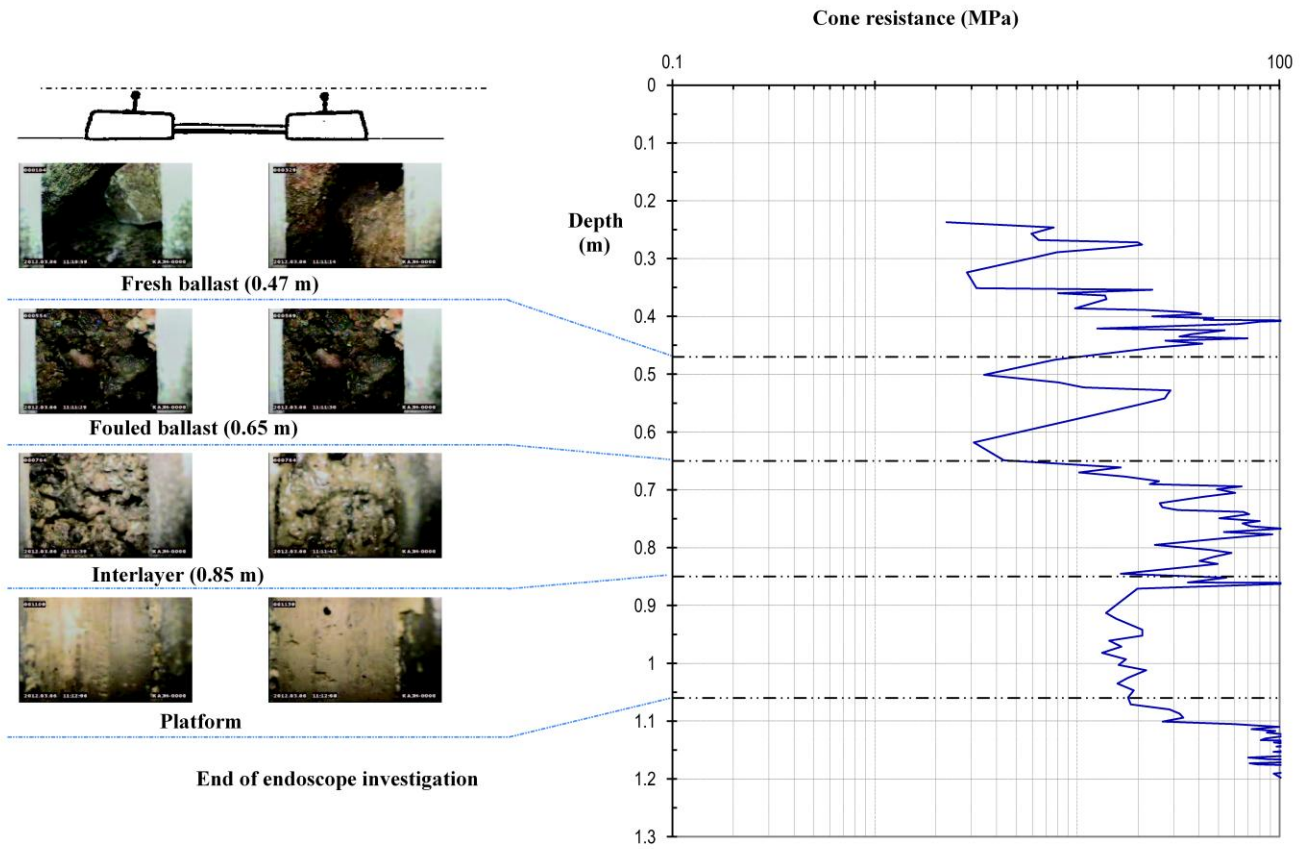
460  
461 **Fig. 11: Typical result from Panda and Endoscope**

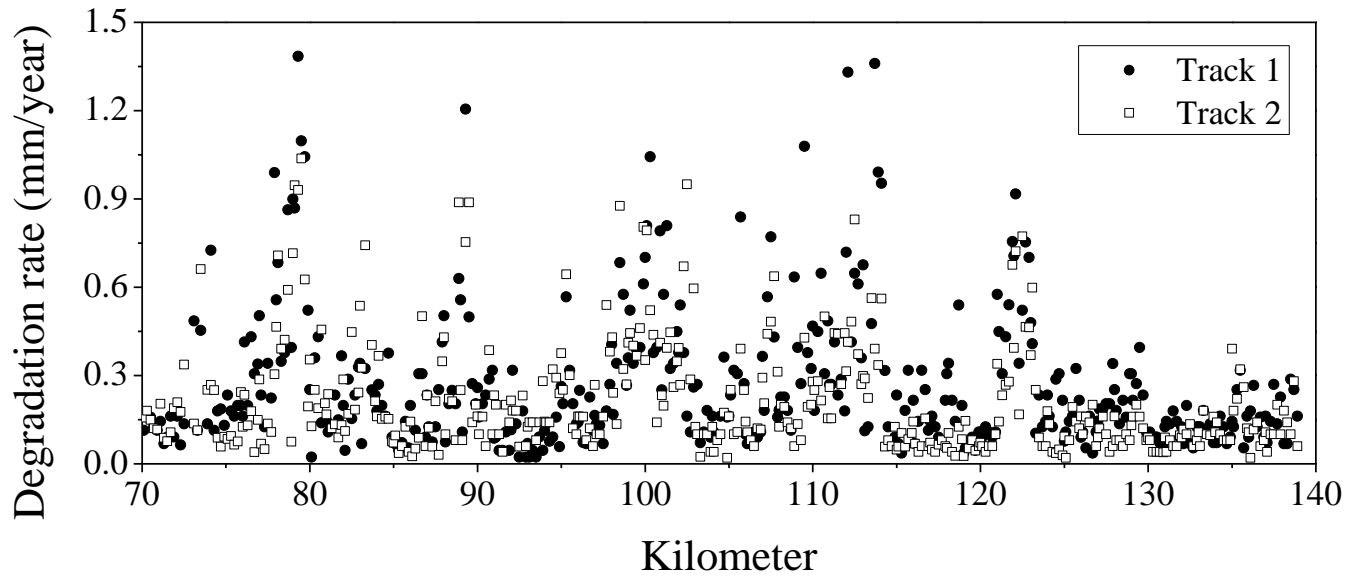
464  
465 **Fig. 12: Degradation rate along the studied line**

235 Fig. 12 depicts the degradation rate (the increase of  $NL$  per year which was calculated from the  
236 slope as presented in Fig. 9) versus the kilometer point for Track 1 and Track 2. On the whole, there is  
237 an agreement between the data of two tracks; the peaks of Track 1 appeared almost at the same  
238 kilometer points as the peaks of Track 2.

248 load and speed and the type of sleeper in two tracks are not necessary identical, the coincidence between  
249 the degradation rates of Track 1 and Track 2 (Fig. 12) confirms that the general cause of the increase of  
250  $NL$  came from the sub-structure. Based on this observation, the following analysis focuses on the sub-  
251 structure.

252 From Fig. 12, the zones with high degradation rates can be identified. They are around PK 73,  
253 79, 88, from 99 to 103, from 106 to 114 and 122. Referring to the geological information, it can be  
254 concluded that these kilometer points correspond to the zones where sub-grades contains large fraction  
255 of fine particles. Around PK 73, the sub-grade is rather argillaceous limestone and marl. Around PK 79,  
256 the sub-grade is fine alluvial deposits and peat. From PK 88 to 89, it is the alluvial deposits overlying the

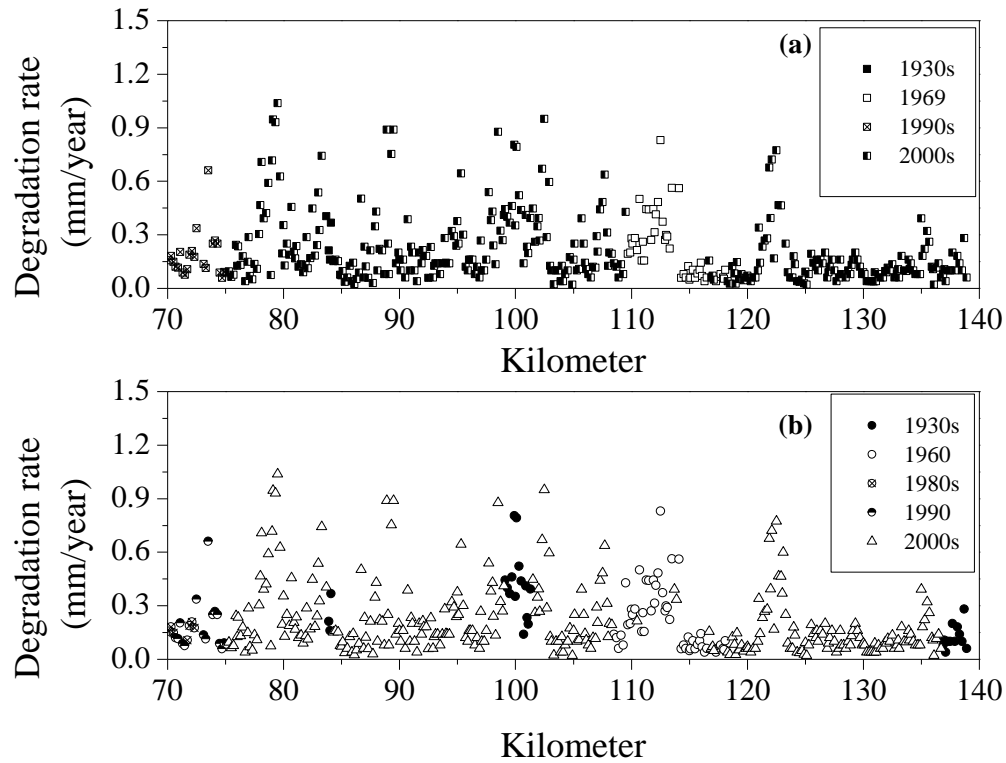
**Fig. 14: Degradation rate of Track 2 according to (a) year of rail and (b) year of sleeper**

239 Fig. 13 and Fig. 14 present the degradation rates according to the year of rail (Fig. a) and the year  
240 of sleeper (Fig. b) for Track 1 and Track 2, respectively. From these figures, it can be seen that there is  
241 no correlation between the year of super-structure (rail or sleeper) and the increase rate of  $NL$ , even  
242 though theoretically in the calculation of  $NL$ , the super-structure can have an influence on the value of  
243  $NL$ . It is worth noting that these data correspond to the year of the current super-structure, and that in  
244 past the types of rail and sleeper could be different. Thus, it is not possible to exclude the contribution of  
245 the super-structure to the degradation of tracks identified. However, as shown in Fig. 9, after the  
246 remedial work of tamping, the value of  $NL$  continued to increase. This suggests that the rail or sleeper  
247 type did not clearly influence the evolution of  $NL$  identified. Furthermore, admitting that the traffic, train

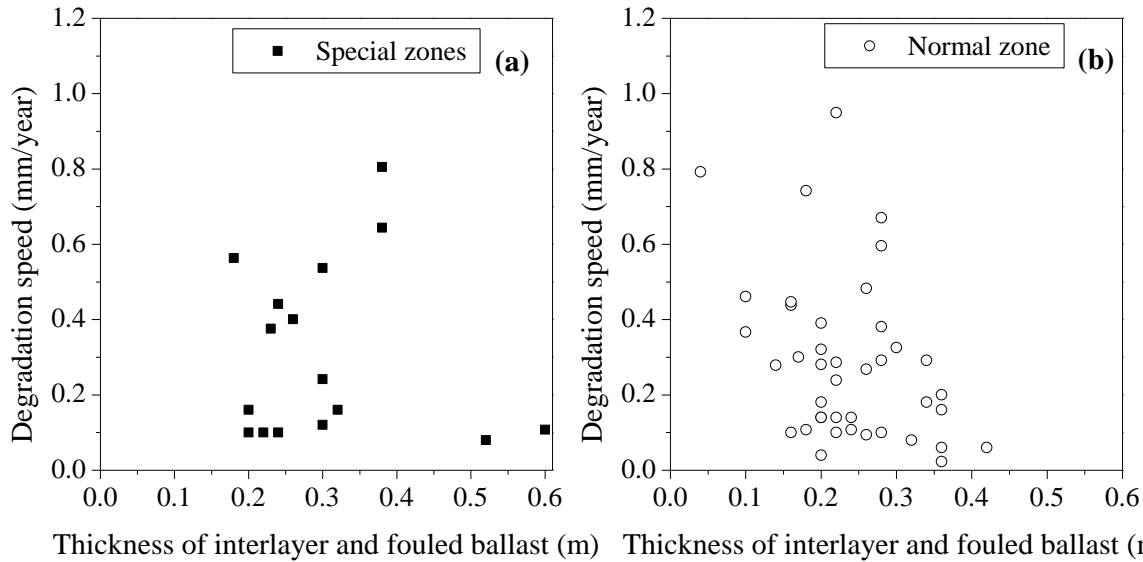
484 Thickness of interlayer and fouled ballast (m) Thickness of interlayer and fouled ballast (m)  
 485 **Fig. 17: Correlation of the degradation rate to the thickness of interlayer and fouled ballast for Track 2- Data from**  
 486 **coring train. a) special zones and b) normal zone**

286 Fig. 16 presents the correlation between the thickness of fouled ballast and interlayer ( $e$ ) and the  
287 increase rate of  $NL$  for special zones (Fig. a) and normal zones (Fig. b), for Track 1. The same  
288 correlation is presented in Fig. 17 for Track 2. The special zones correspond to the zone of stations, the  
289 zones with bridges or viaducts. The other zones are referred to normal zones. For the special zones,  
290 Track 1 (Fig. 16a) presents a sharp decrease trend of degradation rate with the increase of  $e$ , while this  
291 trend is not observed for Track 2 (Fig. 17a). For the normal zones, despite the data scatter that can be  
292 explained by the presence of fouled ballast taken into account in the study, both Track 1 (Fig. 16a) and  
293 Track 2 (Fig. 17a) present a decrease of degradation rate as the layers thickness increases. As mentioned  
294 before, in the sub-structure of new lines for high speed train, there are a number of layers protecting
