Durability of flax/bio-epoxy composites intended for strengthening applications in construction

DURABILITY OF FLAX/BIO-EPOXY COMPOSITES INTENDED FOR STRENGTHENING APPLICATIONS IN CONSTRUCTION

K. Benzarti^{1,*}, R. Chlela¹, M. Quiertant², S. Zombre³, L. Curtil³, M. Michel³

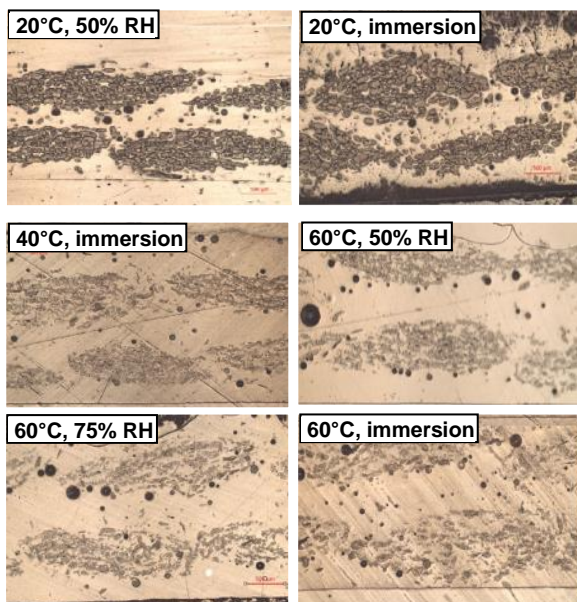
Fig. 4: Microscopic observations of polished cross-sections of FFRP laminates after being subjected to various ageing conditions for 3 months.

Fig. 4 displays pictures of specimens aged for 3 months in the various environments. Two main features are revealed by these images:

- First, a variation of the apparent section of flax fibers can be noticed, depending on the ageing conditions. An increase in the fiber section is observed for laminates subjected to 20°C in immersion compared to those stored at 20°C-50% RH, which can be assigned to the swelling of flax fibers induced by water absorption. Differently, specimens exposed to elevated temperatures show reduced fiber sections compared to those stored at 20°C, whatever the level of relative humidity. This may result from a modification of the fiber structure, which is not clearly identified at this stage (collapse of the internal hollow structure, extraction of soluble components?). Nevertheless, it suggests that for FFRP composites immersed at high temperature, the extensive sorption process evidenced in Fig. 2 results from water absorption by the polymer matrix and interfacial areas, and not by the fibers themselves.

- Besides, lightening and change of colour of the flax fibers (which turns to light honey colour) are observed for FFRP laminates exposed to high temperatures.

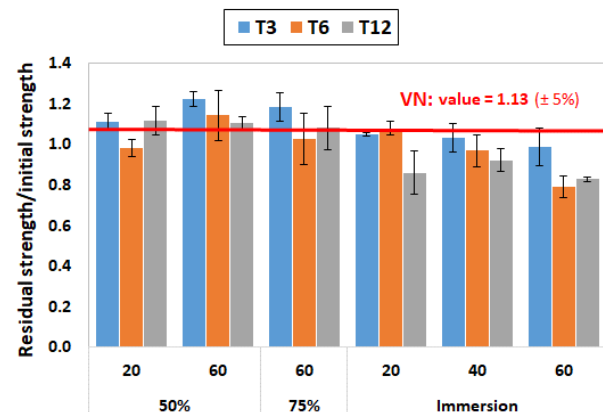
Fig. 4: Normalized residual strengths of specimens that were exposed to the various ageing conditions for periods up to 12 months. (T3, T6 and T12). The red line shows the value of the specimen exposed to weathering conditions (VN) for 12 months.

Fig. 4 and Fig. 5 report the normalized residual tensile properties (residual strength and modulus, respectively) obtained for FFRP laminates subjected to ageing periods up to 12 months in the various environments.

Regarding the tensile strength (Fig. 4), FRP composites didn't show any degradation after 3 months ageing, and a significant increase was even observed for specimens exposed to the temperature of 60°C at 50% and 75% RH, which was explained by the post-curing process of the bio epoxy matrix as previously evidenced by DSC analyses. Between 3 and 12 months ageing, specimens immersed in water show a 20% reduction of their residual strength, with a kinetics that is dependent on ageing temperature (the higher the temperature, the higher the degradation kinetics). This feature can be correlated to the water sorption kinetics, which is also temperature dependent as shown previously in section 3.1.

Specimens exposed to outdoor conditions for 12 months exhibit a slight increase in tensile strength compared to the reference, probably due to the post-cure effect evidenced by DSC.

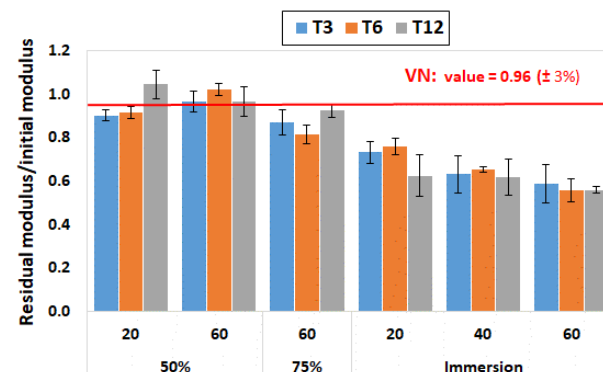
Fig. 5: Normalized residual modulus of specimens that were exposed to the various ageing conditions for periods up to 12 months (T3, T6 and T12). The red line shows the value of the specimen exposed to weathering conditions (VN) for 12 months.

Regarding the evolution of the tensile Young's modulus (Fig. 5), the increase in humidity is found to degrade significantly the longitudinal stiffness of the FRP laminates over ageing. This effect is usually accompanied by an increase in ultimate elongation. For immersed specimens, the drop of modulus can reach up to 40% after 12 months at 60°C-100% RH. Such phenomena can be assigned to a plasticization effect induced by water on the polymer matrix, and to degradations (cracks) occurring within the matrix and at fiber/matrix interfaces due to swelling of the polymer and alteration of the fiber sections, as shown previously in Figs. 4 and 5.

An interesting point is that natural ageing (12 months exposure to outdoor conditions) does not affect the stiffness of the FRP laminate significantly, differently from what is observed with accelerated ageing tests, especially under immersion. This result suggests that immersion conditions are very severe compared to natural ageing.

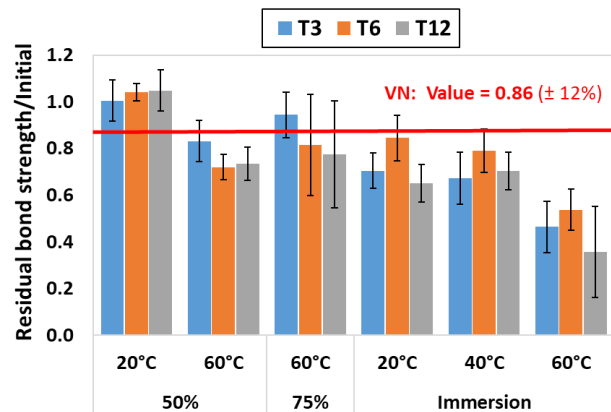
Fig. 6: Normalized residual bond strength between FRPs and concrete after exposure to the various ageing conditions for periods up to 12 months. The red line shows the value of the specimen exposed to weathering conditions (VN) for 12 months.

Residual pull-off strength determined on specimens aged in the various accelerated conditions over periods from 3 to 12 months (T3 to T12) are then displayed in Fig. 6. Values are normalized by the reference value, i.e. the mean pull-off strength of unaged specimens.

A significant decrease in bond strength was observed for all specimens, with the exception of those stored at 20°C-50% RH. Moreover, samples directly immersed in water were the most affected, with a reduction up to 50% in the case of samples subjected to 60°C-100% RH, which is also consistent with the large water uptake evidenced for FRP composites in these conditions (Fig. 2). Such a degradation of the bond strength under wet conditions was accompanied by a change in failure mode, from an initial cohesive concrete failure towards a mixed failure mode (Fig. 7b) or FRP debonding mode (Fig. 7c) after ageing. This change in failure mode and the reduction in bond strength can both be attributed to a weakening of physico-chemical bonds at the concrete/composite interface in presence of water.

Here again, a very interesting feature is that specimens aged under natural weathering conditions (VN) for 12 months show only limited reduction of their pull-off
