Durability of flax/bio-epoxy composites intended for strengthening applications in construction

DURABILITY OF FLAX/BIO-EPOXY COMPOSITES INTENDED FOR STRENGTHENING APPLICATIONS IN CONSTRUCTION

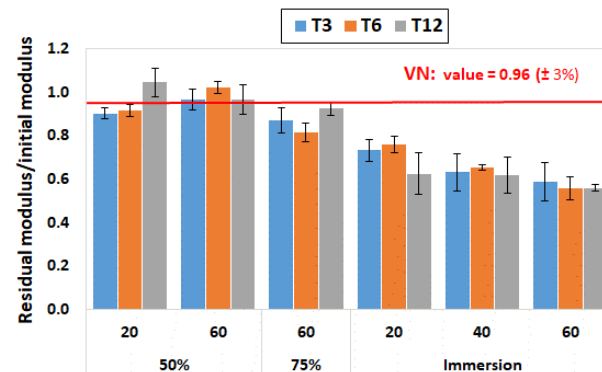
Fig. 5: Normalized residual modulus of specimens that were exposed to the various ageing conditions for periods up to 12 months (T3, T6 and T12). The red line shows the value of the specimen exposed to weathering conditions (VN) for 12 months.

Regarding the evolution of the tensile Young's modulus (Fig. 5), the increase in humidity is found to degrade significantly the longitudinal stiffness of the FRP laminates over ageing. This effect is usually accompanied by an increase in ultimate elongation. For immersed specimens, the drop of modulus can reach up to 40% after 12 months at 60°C-100% RH. Such phenomena can be assigned to a plasticization effect induced by water on the polymer matrix, and to degradations (cracks) occurring within the matrix and at fiber/matrix interfaces due to swelling of the polymer and alteration of the fiber sections, as shown previously in Figs. 4 and 5.

An interesting point is that natural ageing (12 months exposure to outdoor conditions) does not affect the stiffness of the FRP laminate significantly, differently from what is observed with accelerated ageing tests, especially under immersion. This result suggests that immersion conditions are very severe compared to natural ageing.

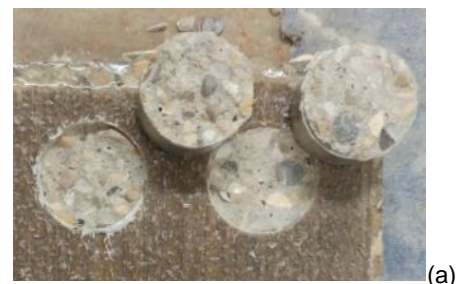
Fig. 7: Failure modes after pull-off tests - (a) initial cohesive concrete failure on unaged specimens, (b) typical mixed failure and (c) composite debonding obtained for specimens subjected to wet ageing.

Adhesive bond properties were assessed by pull-off tests. In a preliminary stage, reference properties were determined on unaged FRP strengthened concrete slabs, giving an average value of 4.09 ± 0.25 MPa for the pull-off strength and a typical cohesive concrete failure (Fig. 7.a).

strength (~14%), together with a mixed failure mode similar to that presented in Fig. 7.b. This suggests once more that natural ageing might be less severe compared to accelerated ageing by immersion in water.
