Durability of flax/bio-epoxy composites intended for strengthening applications in construction

DURABILITY OF FLAX/BIO-EPOXY COMPOSITES INTENDED FOR STRENGTHENING APPLICATIONS IN CONSTRUCTION

K. Benzarti^{1,*}, R. Chlela¹, M. Quiertant², S. Zombre³, L. Curtil³, M. Michel³

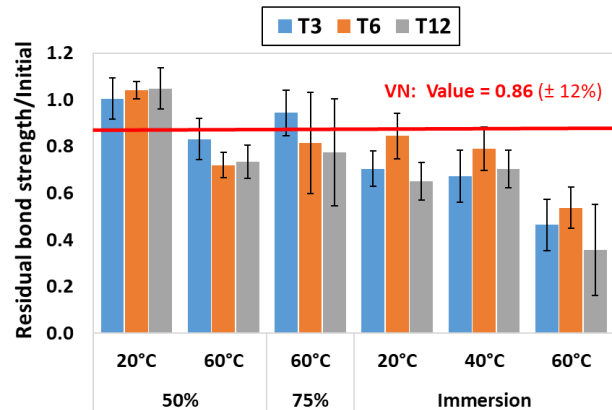
Residual pull-off strength determined on specimens aged in the various accelerated conditions over periods from 3 to 12 months (T3 to T12) are then displayed in Fig. 6. Values are normalized by the reference value, i.e. the mean pull-off strength of unaged specimens.

A significant decrease in bond strength was observed for all specimens, with the exception of those stored at 20°C-50% RH. Moreover, samples directly immersed in water were the most affected, with a reduction up to 50% in the case of samples subjected to 60°C-100% RH, which is also consistent with the large water uptake evidenced for FRP composites in these conditions (Fig. 2). Such a degradation of the bond strength under wet conditions was accompanied by a change in failure mode, from an initial cohesive concrete failure towards a mixed failure mode (Fig. 7b) or FRP debonding mode (Fig. 7c) after ageing. This change in failure mode and the reduction in bond strength can both be attributed to a weakening of physico-chemical bonds at the concrete/composite interface in presence of water.

Here again, a very interesting feature is that specimens aged under natural weathering conditions (VN) for 12 months show only limited reduction of their pull-off

Fig. 6: Normalized residual bond strength between FRPs and concrete after exposure to the various ageing conditions for periods up to 12 months. The red line shows the value of the specimen exposed to weathering conditions (VN) for 12 months.
