Durability of flax/bio-epoxy composites intended for strengthening applications in construction

DURABILITY OF FLAX/BIO-EPOXY COMPOSITES INTENDED FOR STRENGTHENING APPLICATIONS IN CONSTRUCTION

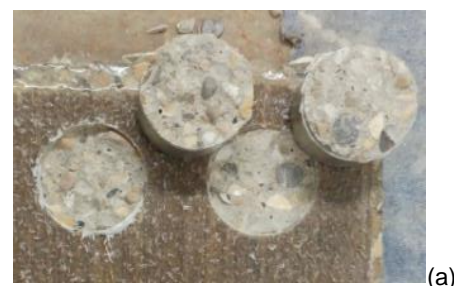
Fig. 7: Failure modes after pull-off tests - (a) initial cohesive concrete failure on unaged specimens, (b) typical mixed failure and (c) composite debonding obtained for specimens subjected to wet ageing.

Adhesive bond properties were assessed by pull-off tests. In a preliminary stage, reference properties were determined on unaged FRP strengthened concrete slabs, giving an average value of 4.09 ± 0.25 MPa for the pull-off strength and a typical cohesive concrete failure (Fig. 7.a).

strength (~14%), together with a mixed failure mode similar to that presented in Fig. 7.b. This suggests once more that natural ageing might be less severe compared to accelerated ageing by immersion in water.
