## Durability of flax/bio-epoxy composites intended for strengthening applications in construction

Karim Benzarti, Robert Chlela, Marc Quiertant, Wendlamita Zombré,  
Laurence Curtil, Marie Michel

## DURABILITY OF FLAX/BIO-EPOXY COMPOSITES INTENDED FOR STRENGTHENING APPLICATIONS IN CONSTRUCTION

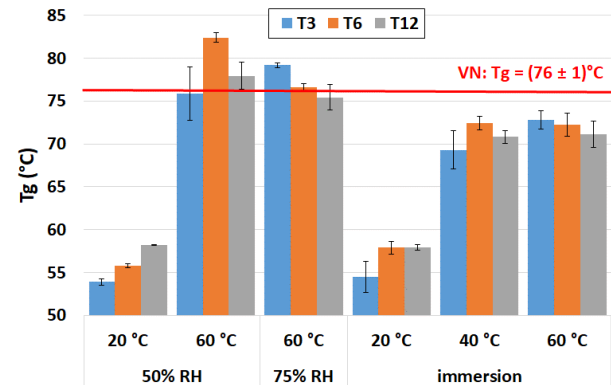
Fig. 3. reports values of the glass transition temperature ( $T_g$ ) measured by DSC on FFRP laminates aged in the various environments for periods of 3, 6 and 12 months.

$T_g$  of the specimen exposed to weathering conditions (VN) for 12 months is depicted by the red line.

Fig. 3:  $T_g$  of FFRP laminates after exposure from 3 to 12 months ( $T_3$  to  $T_{12}$ ) in the various ageing conditions. Red line corresponds to  $T_g$  level after 12 months outdoor exposure (VN).

Reference  $T_g$  value measured for the unaged laminate cured for 3 weeks at room temperature was  $55.0 \pm 0.5^\circ\text{C}$ . Such a low  $T_g$  is characteristic of an under-cured state of the polymer matrix, in which the polymerization process didn't reach completion.

From Fig. 3, it is found that  $T_g$  of the specimen aged at 20°C under moderate humidity (50% RH) increases slowly over time, without overpassing  $58^\circ\text{C}$  after 12 months. This is due to the very slow reaction kinetics of residual monomers at this temperature. A similar trend is observed at 20°C under immersion, for the same reason.

Exposure to 60°C under moderate humidity (50% RH) leads first to a very large increase in  $T_g$  during the first 6 months (up to  $82^\circ\text{C}$ ), followed by a slight decrease over the next 6 months. The first increase can be assigned to the post-curing process of the polymer matrix, as the elevated temperature facilitates the diffusion of unreacted monomers and promotes further crosslinking of the thermoset network. In the second stage, the decay may result from oxidation induced degradation (to be confirmed by FTIR analyses).

Ageing at 60°C and 75% RH leads also to a sharp increase in  $T_g$  during the first 3 months, followed by a decay after 6 and 12 months, which may relate to the effect of humidity through a plasticization process. Oxidation-induced degradation may also be involved at long ageing times.

Regarding samples immersed in water (100% RH) at elevated temperatures (40 and 60°C), an initial  $T_g$  increase is also observed during the first 3 months due to post-cure (the higher the ageing temperature, the higher this  $T_g$  increase). However, such an increase remains limited compared to that obtained at 60°C under moderate or intermediate humidity levels (50 and 75% RH). This result suggests that, under wet environment, the evolution of  $T_g$  may be controlled by both the post-cure process and the plasticization by water, which have opposite effects on  $T_g$  [14-16]. At longer times (12 months at 40°C and 6 months at 60°C), a decreasing variation of  $T_g$  is observed again, suggesting that plasticization effect becomes predominant.

A very interesting feature is that  $T_g$  measured on specimens exposed for 12 months to outdoor conditions is about  $76^\circ\text{C}$  (very close to  $T_g$  value obtained after 12

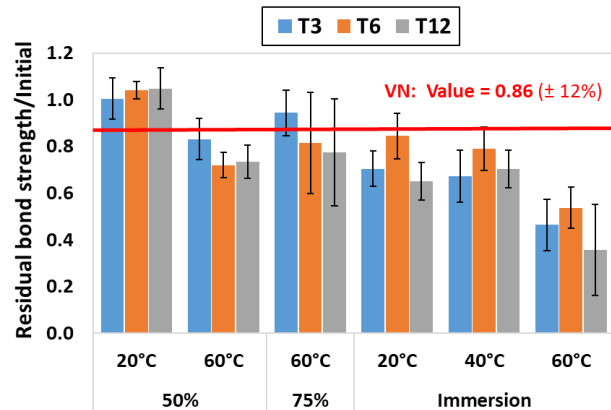
Residual pull-off strength determined on specimens aged in the various accelerated conditions over periods from 3 to 12 months (T3 to T12) are then displayed in Fig. 6. Values are normalized by the reference value, i.e. the mean pull-off strength of unaged specimens.

Fig. 6: Normalized residual bond strength between FRPs and concrete after exposure to the various ageing conditions for periods up to 12 months. The red line shows the value of the specimen exposed to weathering conditions (VN) for 12 months.

A significant decrease in bond strength was observed for all specimens, with the exception of those stored at 20°C-50% RH. Moreover, samples directly immersed in water were the most affected, with a reduction up to 50% in the case of samples subjected to 60°C-100% RH, which is also consistent with the large water uptake evidenced for FRP composites in these conditions (Fig. 2). Such a degradation of the bond strength under wet conditions was accompanied by a change in failure mode, from an initial cohesive concrete failure towards a mixed failure mode (Fig. 7b) or FRP debonding mode (Fig. 7c) after ageing. This change in failure mode and the reduction in bond strength can both be attributed to a weakening of physico-chemical bonds at the concrete/composite interface in presence of water.

Here again, a very interesting feature is that specimens aged under natural weathering conditions (VN) for 12 months show only limited reduction of their pull-off

strength (~14%), together with a mixed failure mode similar to that presented in Fig. 7.b. This suggests once more that natural ageing might be less severe compared to accelerated ageing by immersion in water.

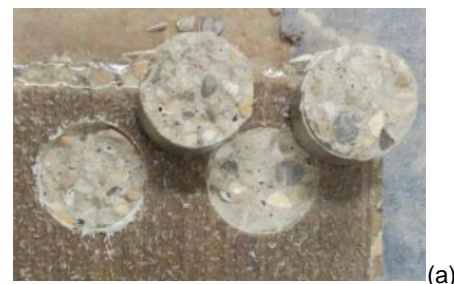
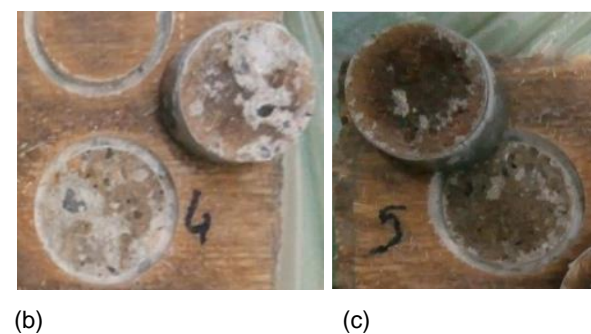
Fig. 7: Failure modes after pull-off tests - (a) initial cohesive concrete failure on unaged specimens, (b) typical mixed failure and (c) composite debonding obtained for specimens subjected to wet ageing.

Adhesive bond properties were assessed by pull-off tests. In a preliminary stage, reference properties were determined on unaged FRP strengthened concrete slabs, giving an average value of  $4.09 \pm 0.25$  MPa for the pull-off strength and a typical cohesive concrete failure (Fig. 7.a).
